4. TITLE (and Subtitle) National Program of Inspection of Non-Federal Dams Tennessee. Reed Lake Dam No. 1 (Inventory Number TN 16706) near Millington, TN, Tipton County, TN, Loosahatchie River Basin		5. TYPE OF REPORT & PERIOD COVERED Phase 1 Investigation Report

14. MONITORING AGENCY NAME & ADDRESS (if different from Controlling Office) Tennessee Department of Conservation Division of Water Resources 4721 Trousdale Drive Nashville, TN 37220		12. REPORT DATE September, 1981

PHASE I INSPECTION
REED LAKE DAM NO. 1
TIPTON COUNTY, TENNESSEE

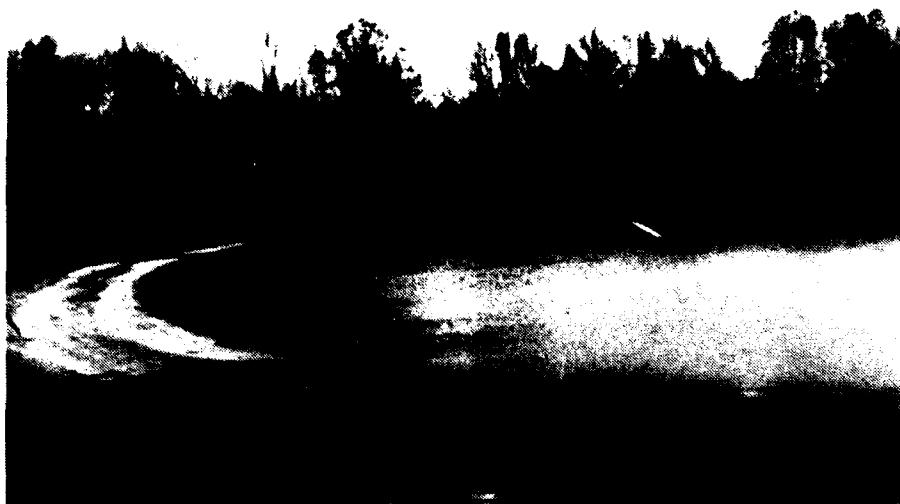
1. Top of Reed Dam No. 1.

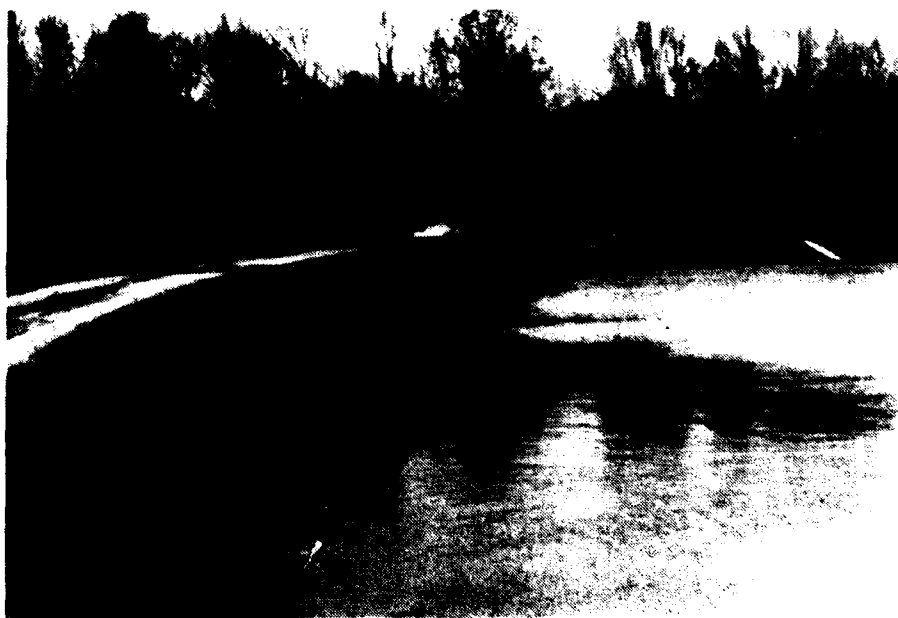
cattle tracks which have punched one to two inch deep tracks when the soil was wet and soft. Above the sloughed and wavecut section, the slopes are about 1V on 3H. There are numerous crayfish holes at the waters edge. A sloughed area about 150 feet west of the abutment has crayfish or boring animal holes just above it. About 250 feet west of the abutment, (See photograph 9), there is slight rilling at the crest. Small holes were found beside a bush to the west of this. These holes could be a product of wave action. More bore holes were found about ten feet west of the service spillway box. There was water in these holes about one inch down.

2. Upstream slope Reed Dam No. 1. Note wave erosion.

- a. Recommend project modifications that will allow the emergency spillway to safely pass the design flood.
- b. Investigate source of water found in auger hole at toe of downstream slope.
- c. Recommend methods to stop erosion on the upstream slope and correct other undesirable conditions on slope.

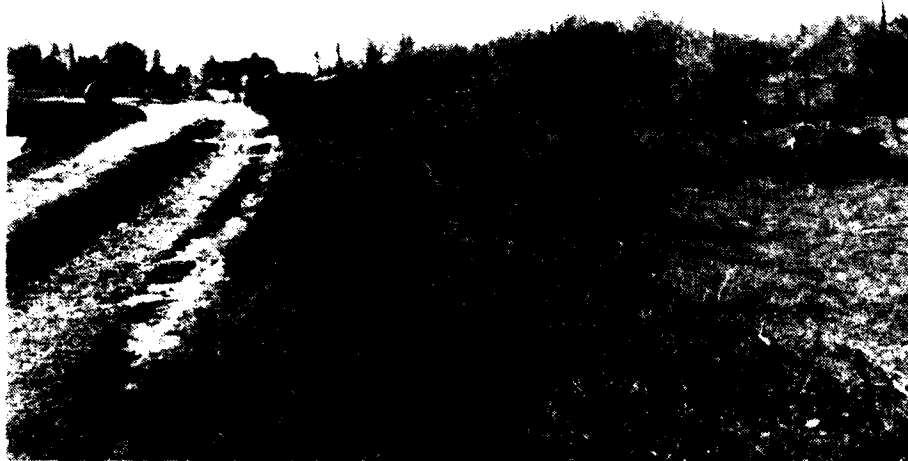
Downstream Slope The downstream slope has been cleared recently of most undesirable growth and debris. The vegetation on the downstream slope was fair. Cattle are grazing on the slope and have caused several eroded paths that run horizontally along the backslope. Erosion was also found under the grass approximately 50 feet from the east abutment. Approximately midway between the outfall for the service spillway and the wet area (See Sketch, page 18), a slight slip was observed approximately five feet above the toe. A small bulge was located on the downstream slope between the east abutment and the outfall pipe. No surface cracks were noted and no evidence of heaving was found on the embankment toe. A utility district has installed a four inch plastic pipe water line along the entire toe of the

3. Downstream slope Reed Dam No. 1. Outfall ditch for service spillway in foreground.

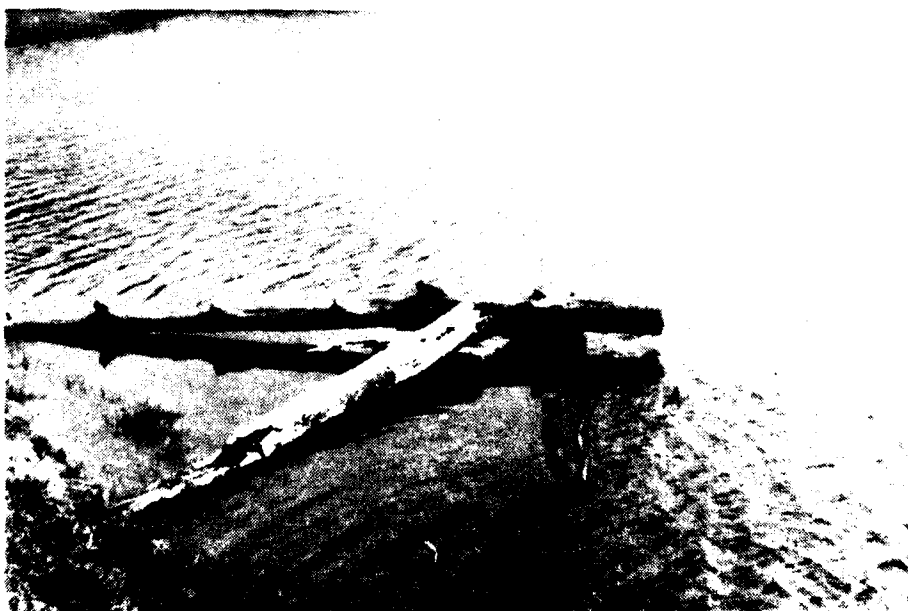
4. Service spillway Reed Dam No. 1. Note absence of antivortex battle or debris guard.

- d. Determine condition of riser and recommend modifications for same to protect it from debris.
- e. Investigate condition of the outfall pipe and suggest remedial measures if necessary.
- f. Evaluate the stability of the dam with earthquake loadings.
- g. Develop a regular program of inspection and maintenance of the embankment and spillways on at least an annual basis.
- h. Develop an emergency action plan to alert downstream residents in the event a major problem develops with Reed Lake Dam No. 1.

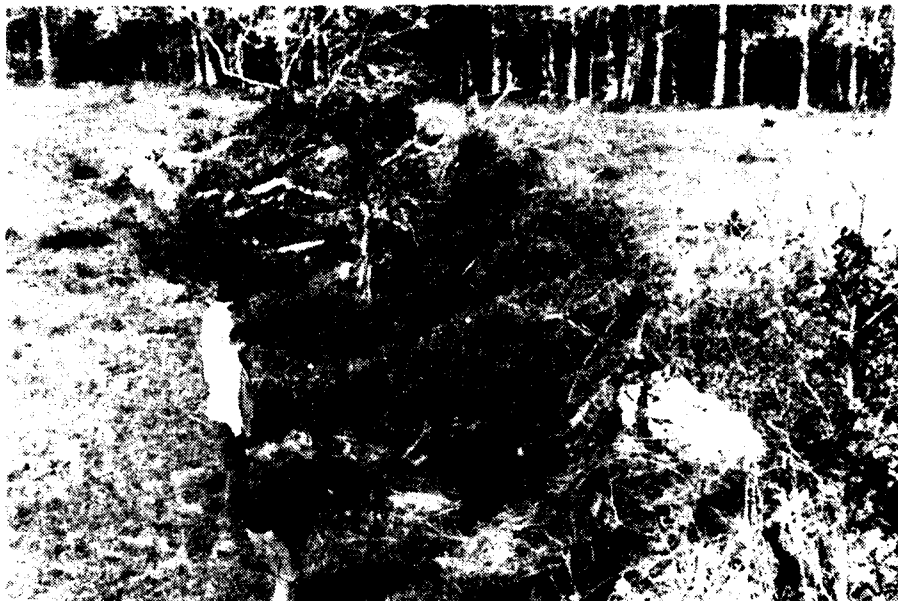
baffle or any means of protection from debris. The condition of the outfall pipe could not be determined since it was buried under a large pile of debris.

5. Outfall for service spillway Reed Dam No. 1. Outfall pipe covered several feet with debris. Flowing water is evidence that pipe is open.

RECOMMENDATIONS. The dam appears to be in good condition but the debris pile needs to be removed from the area over the outlet pipe and exit ditch. An engineering study needs to be made on the possibility of a seepage plane under the dam. The condition of the service spillway pipe needs to be determined after the debris has been removed.

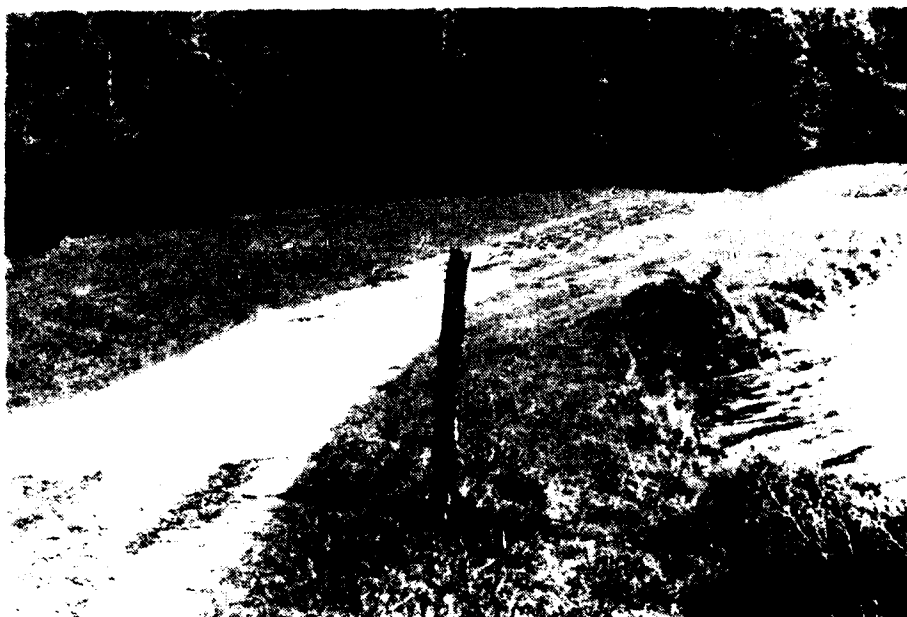
- a. Hydraulic analysis indicates that the Reed Dam No. 1 spillway is seriously inadequate to pass the design flood. Outflow resulting from the $\frac{1}{2}$ PMF will overtop the dam a maximum of 1.75 feet, and produce flow over the dam for four hours.

7. Emergency spillway in right abutment of Reed Dam No. 1. Primarily low point in abutment without design.

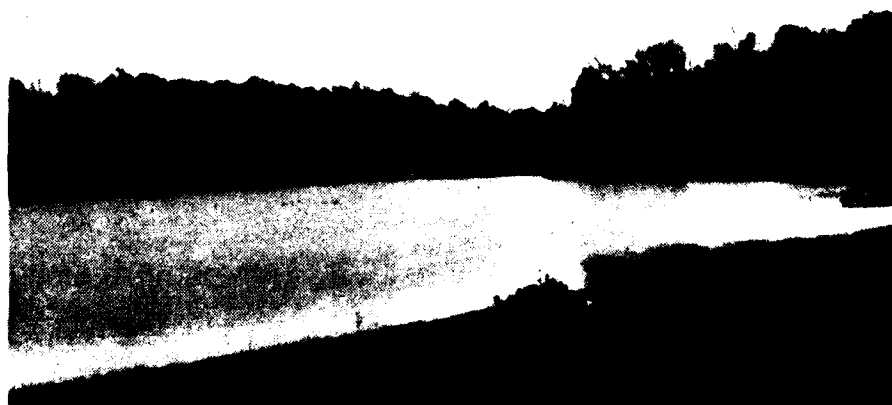
8. Reed Lake No. 1. Note Reed Dam No. 2 at upper end of lake.
